NASA Technical Memorandum 83273

1981 DIRECT STRIKE LIGHTNING DATA

FELIX L. PITTS AND MITCHEL E. THOMAS

This report presents the results obtained during the 1981 direct-strike lightning tests of the NASA Langley Research Center lightning-instrumented F-106B aircraft. The tests were conducted in the vicinity of the National Severe Storms Laboratory, Norman, Oklahoma, and in the vicinity of the NASA Langley Research Center, Hampton, Virginia. The entire strike data obtained for 10 strikes in the 1981 test series are presented in this report.

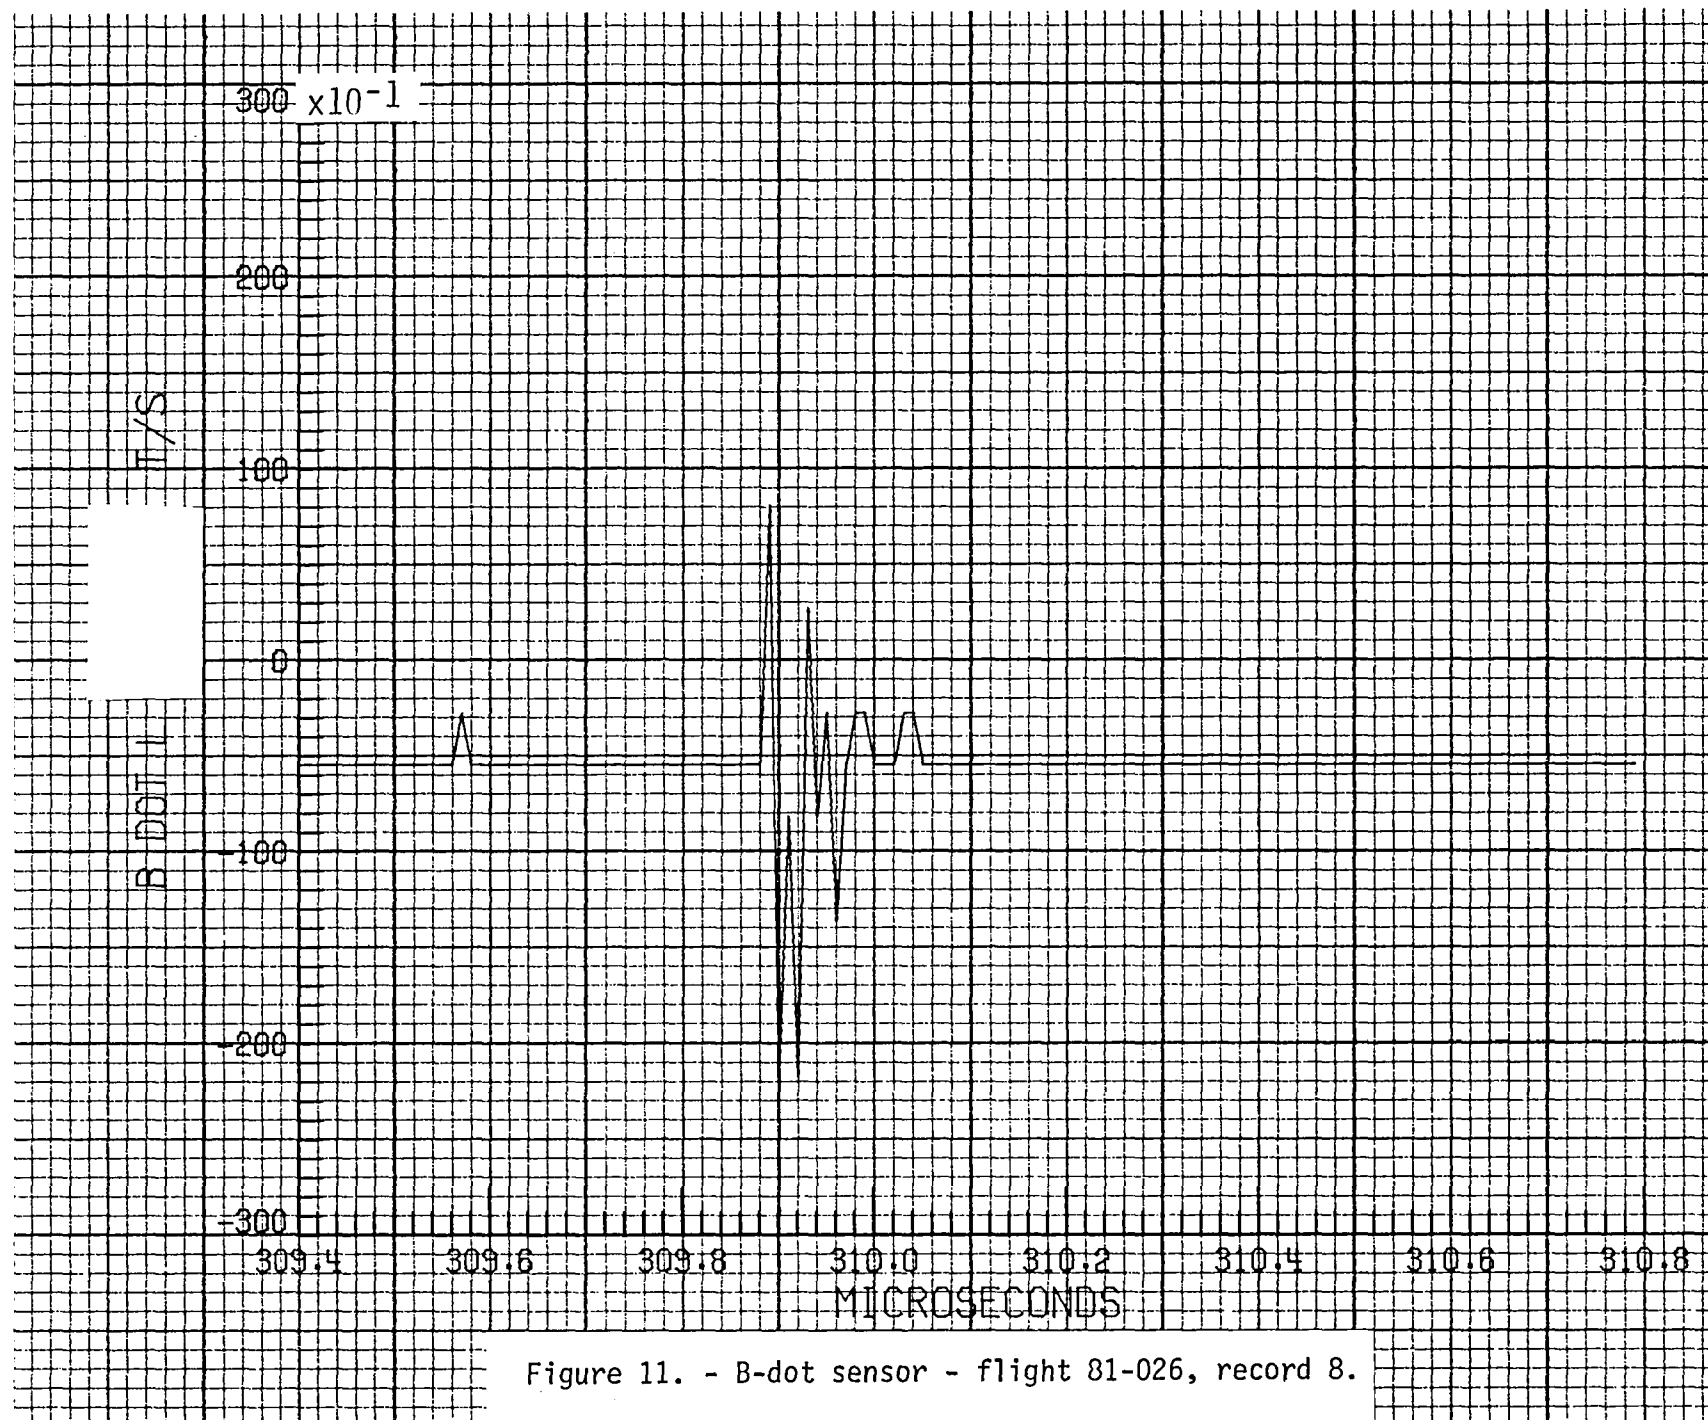
Figure 11. - B-dot sensor - flight 81-026, record 8.

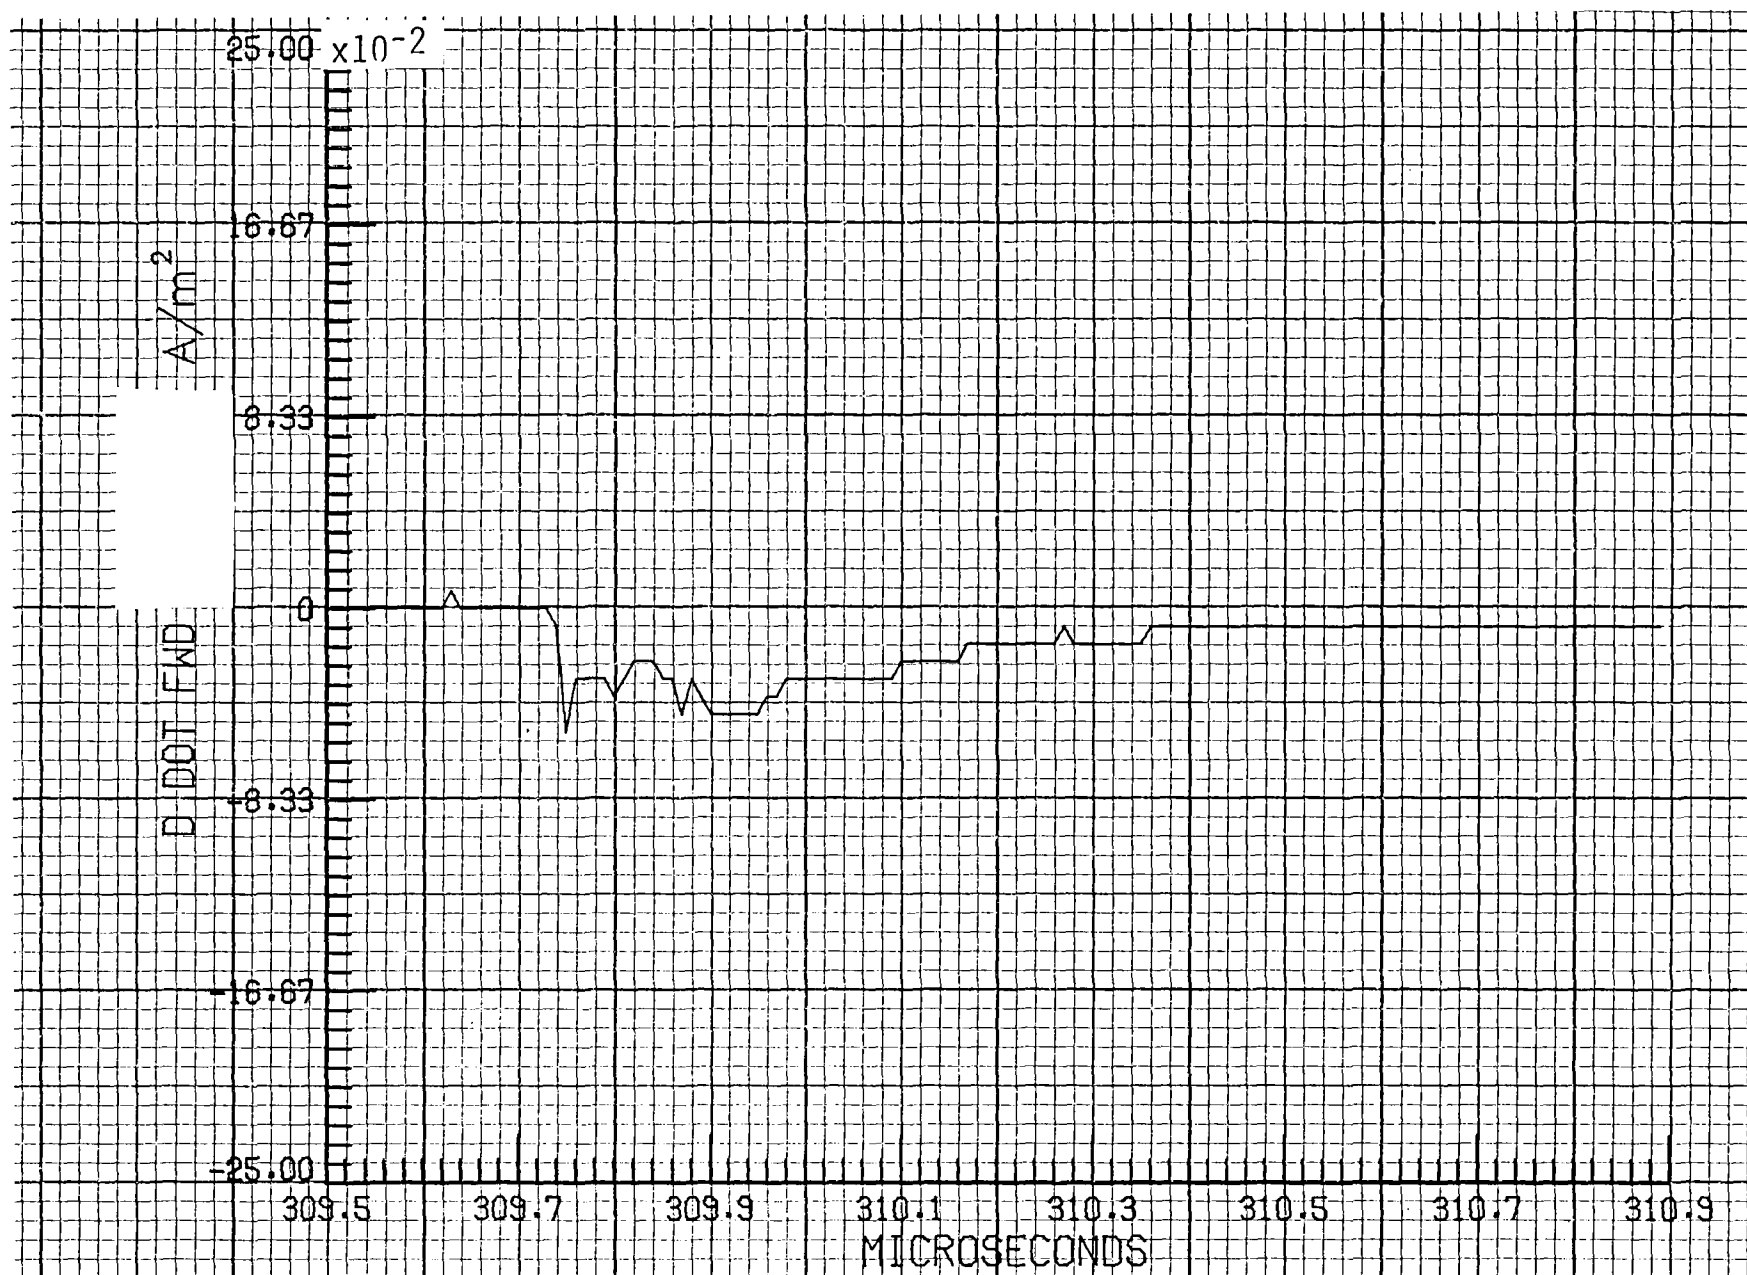
Figure 12. - D-dot sensor - flight 81-026, record 9.

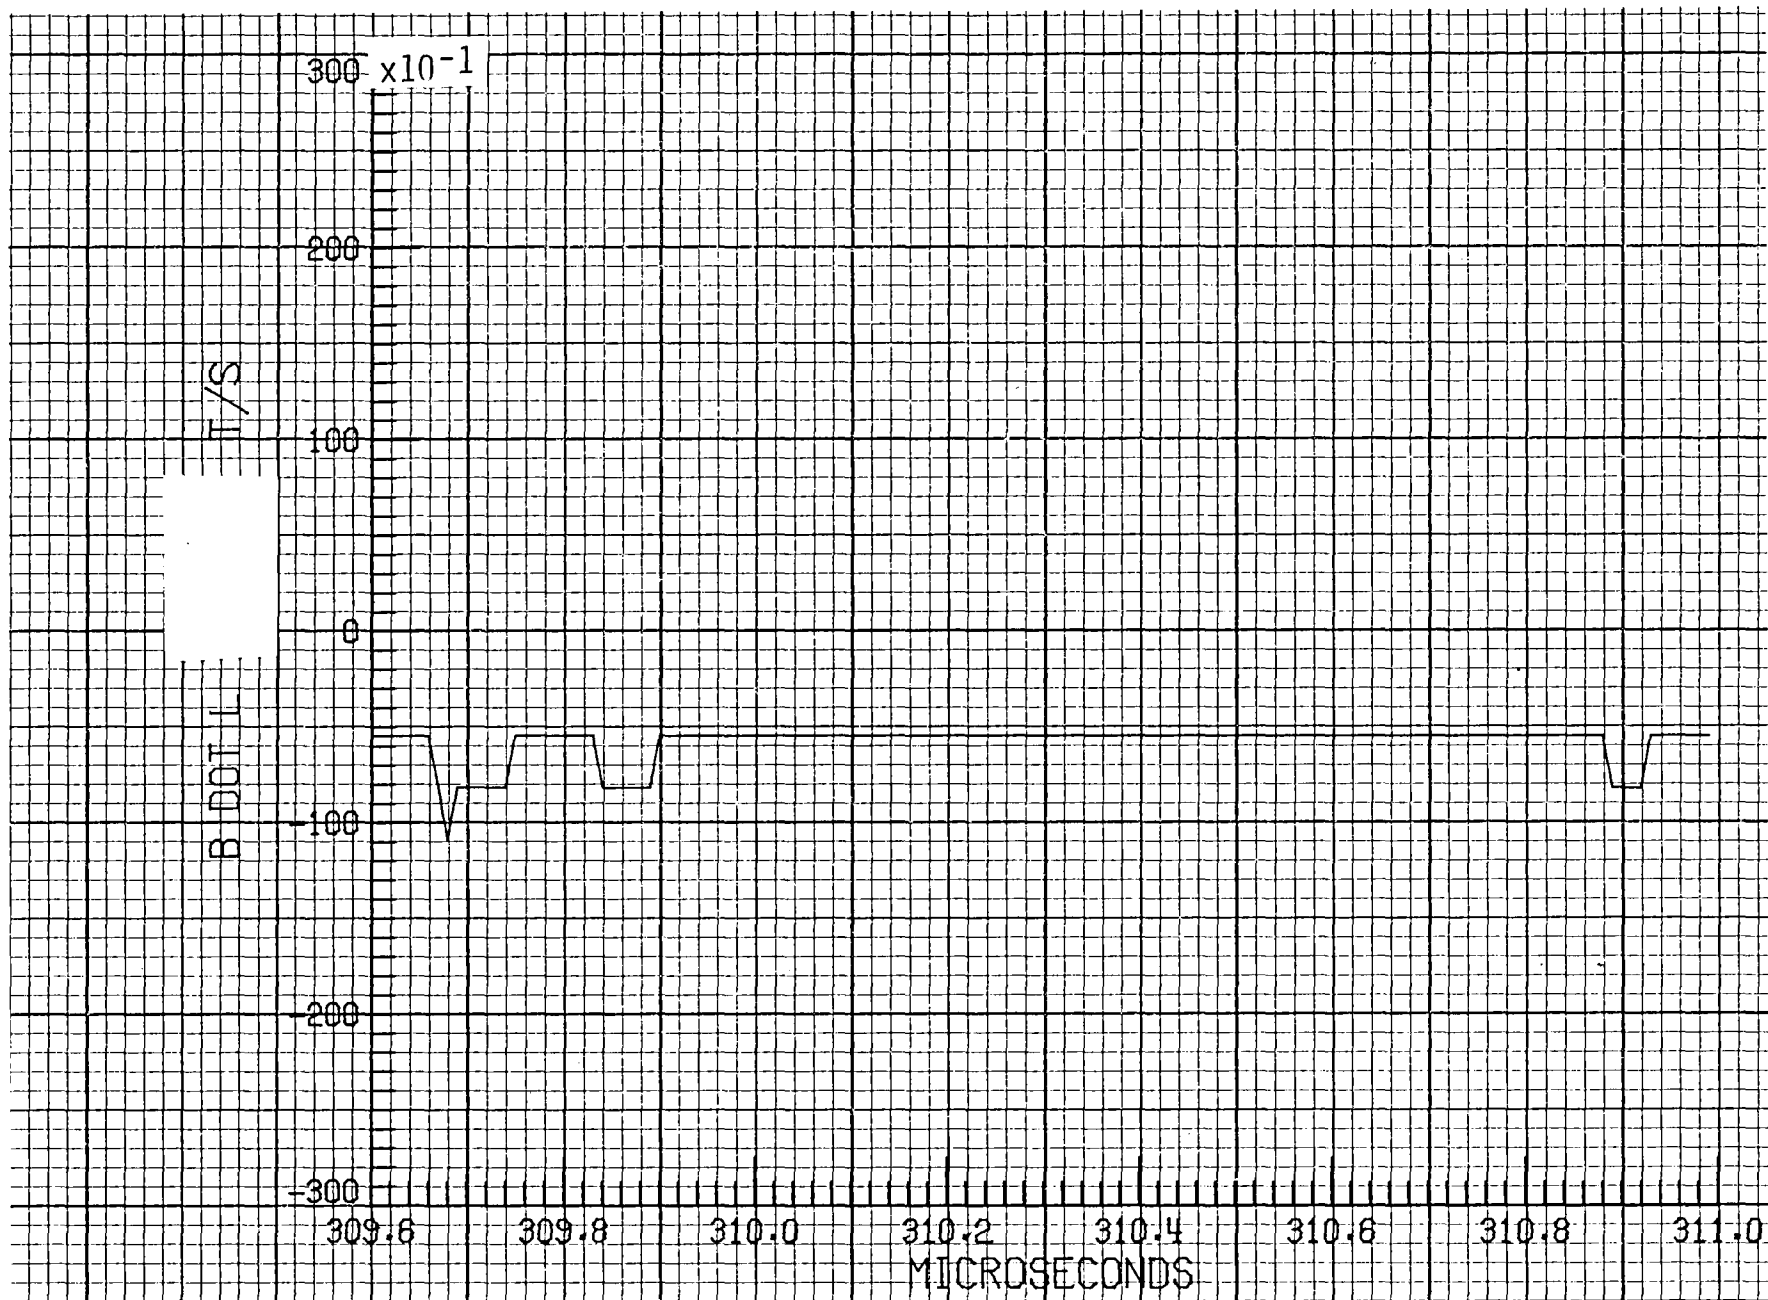
Figure 13. - B-dot sensor - flight 81-026, record 9.

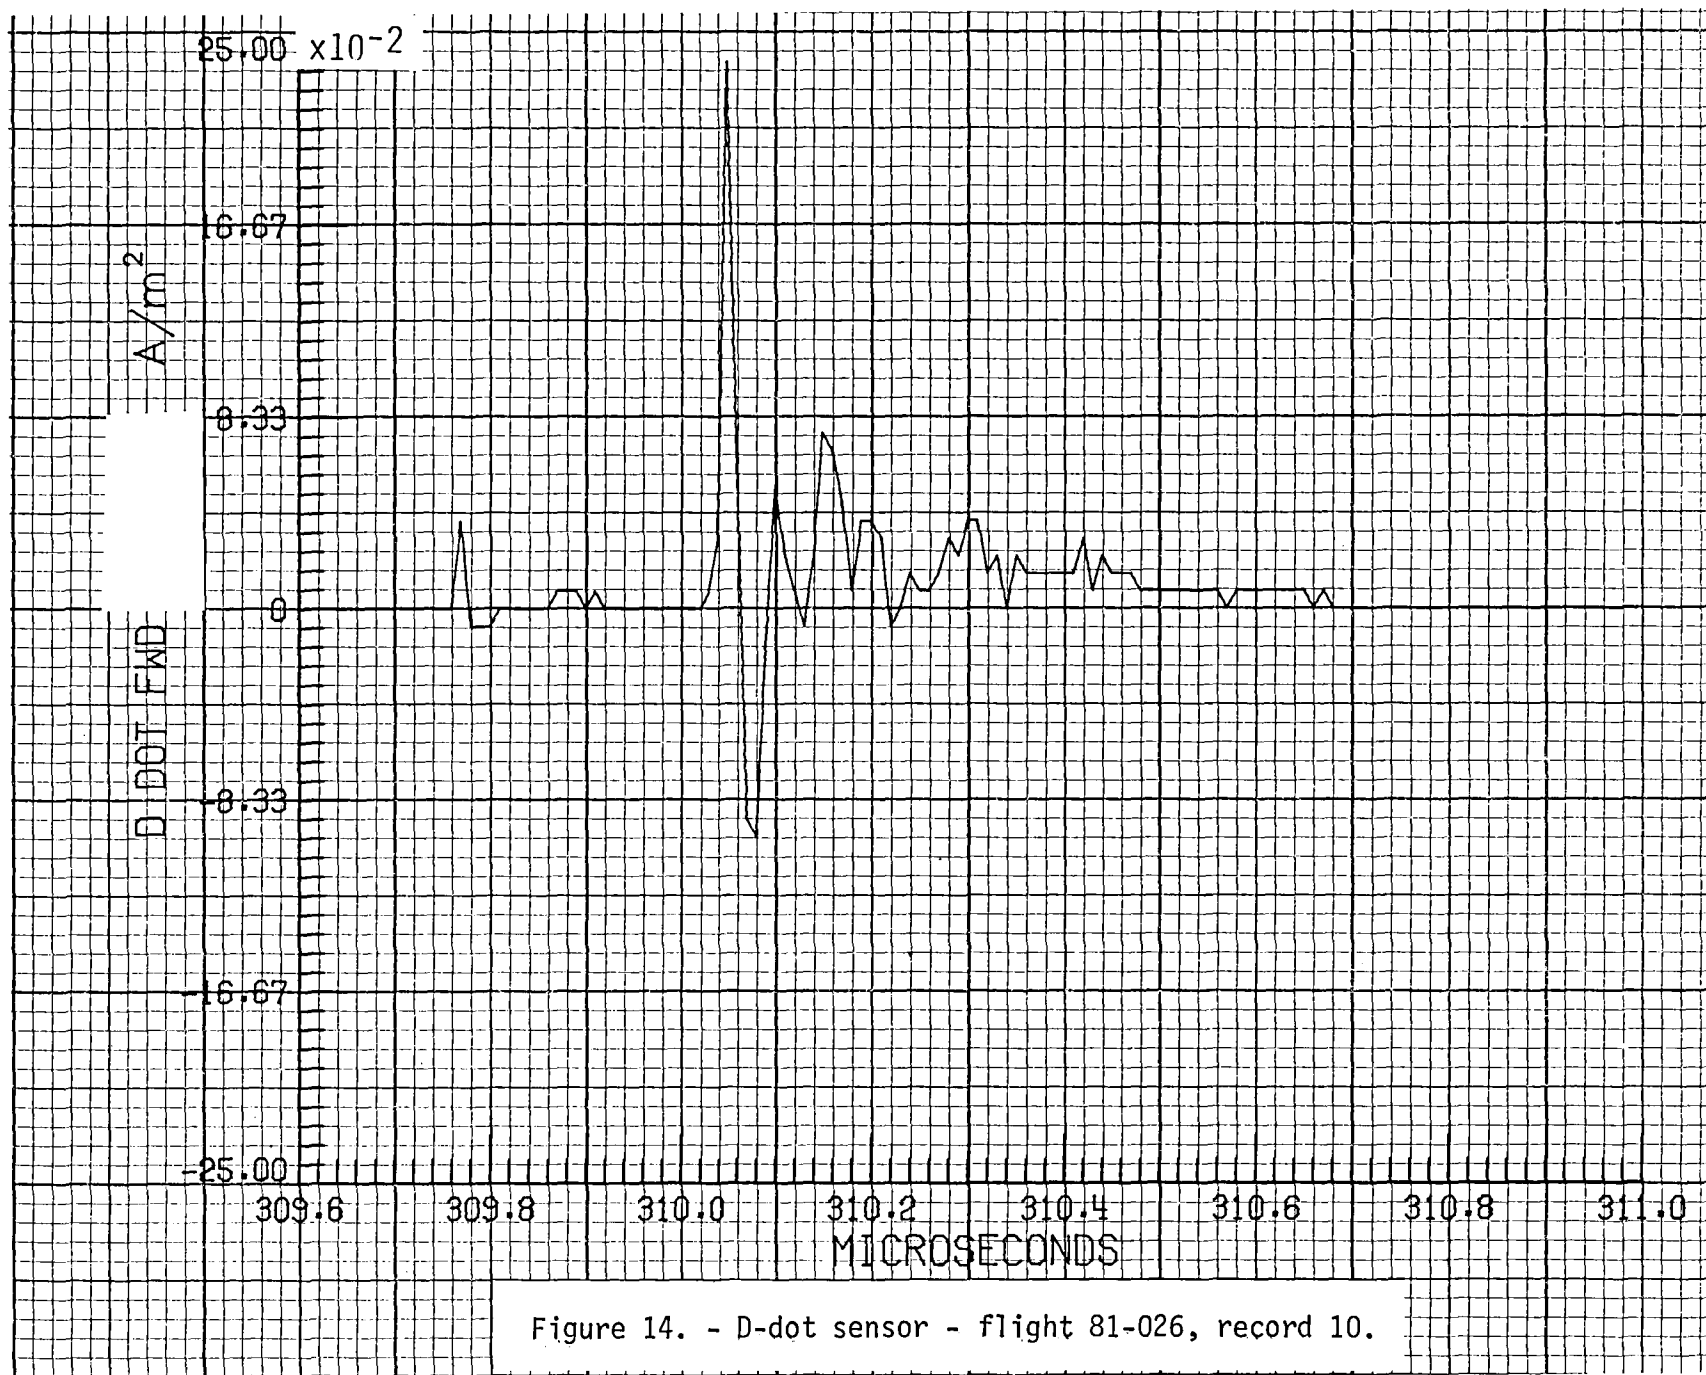
Figure 14. - D-dot sensor - flight 81-026, record 10.

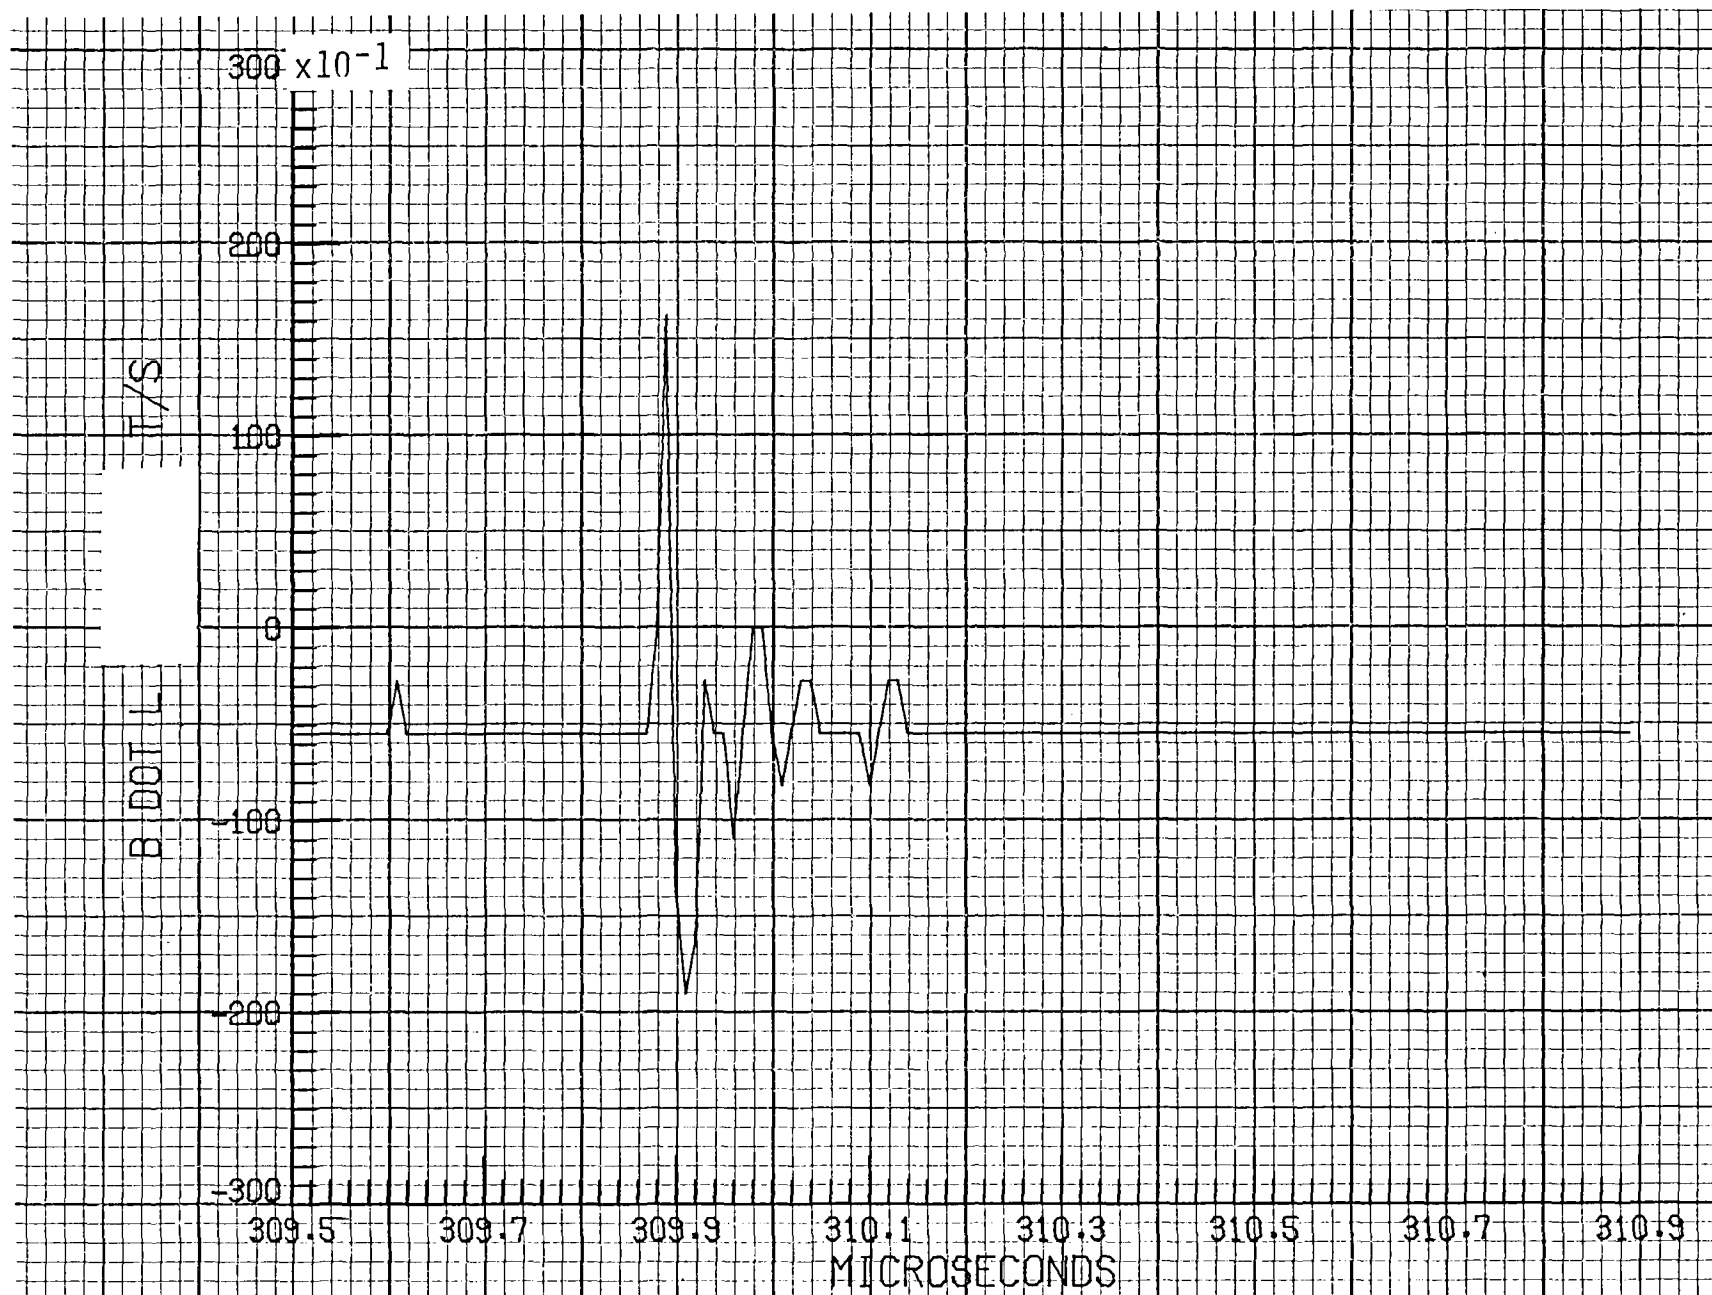
Figure 15. - B-dot sensor - flight 81-026, record 10.

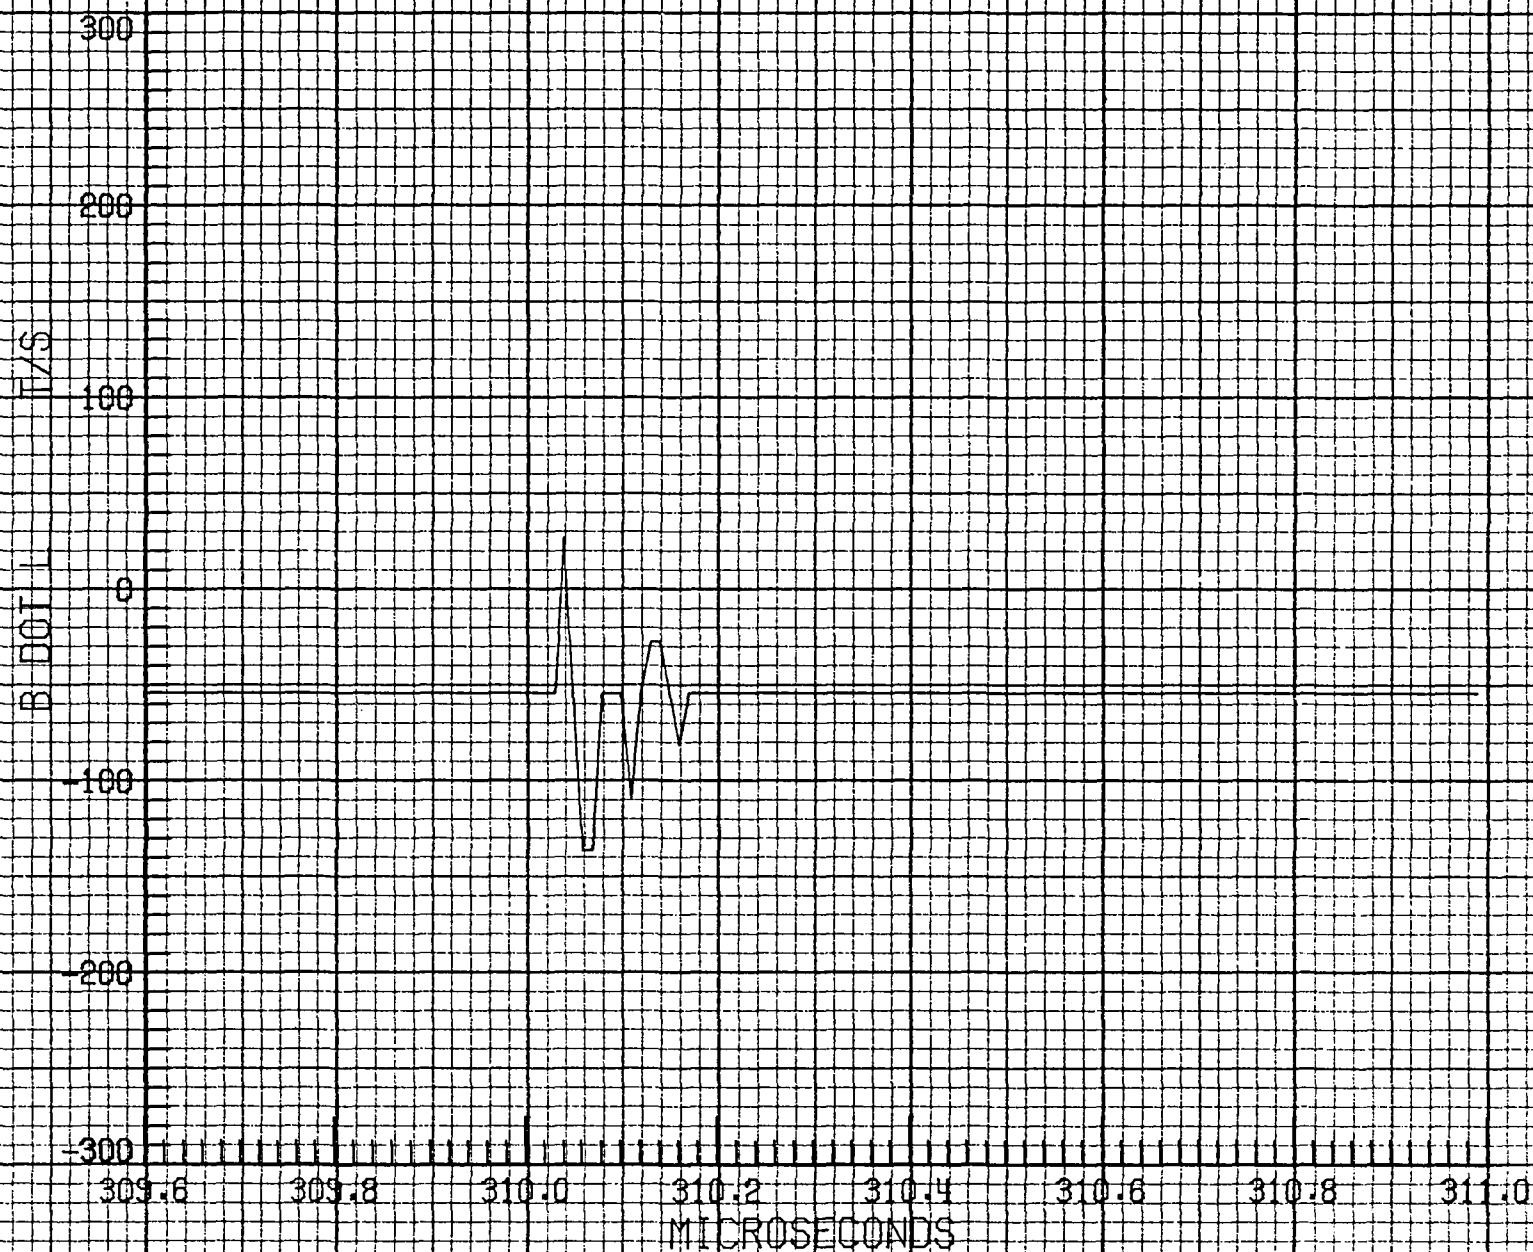
Figure 16. - B-dot sensor - flight 81-041, record 1.

The 1981 data set includes transients recorded for a number of lightning events which were not reported by the pilot as strikes to the aircraft, as in figures 16-18 and 20-27. The only measurement of pilot reported direct lightning attachment occurred during flight 81-043 (figures 19, 28, 31) when the current, I , in the pitot boom was recorded by the aforementioned Boeing Company developed data logger. Even though post-flight examinations of the aircraft reveal that all ten lightning attachments in 1981 were initially to the pitot boom, the magnitude of current in the boom was below the measurement system threshold of 6000 amperes in every case except flight 81-043.

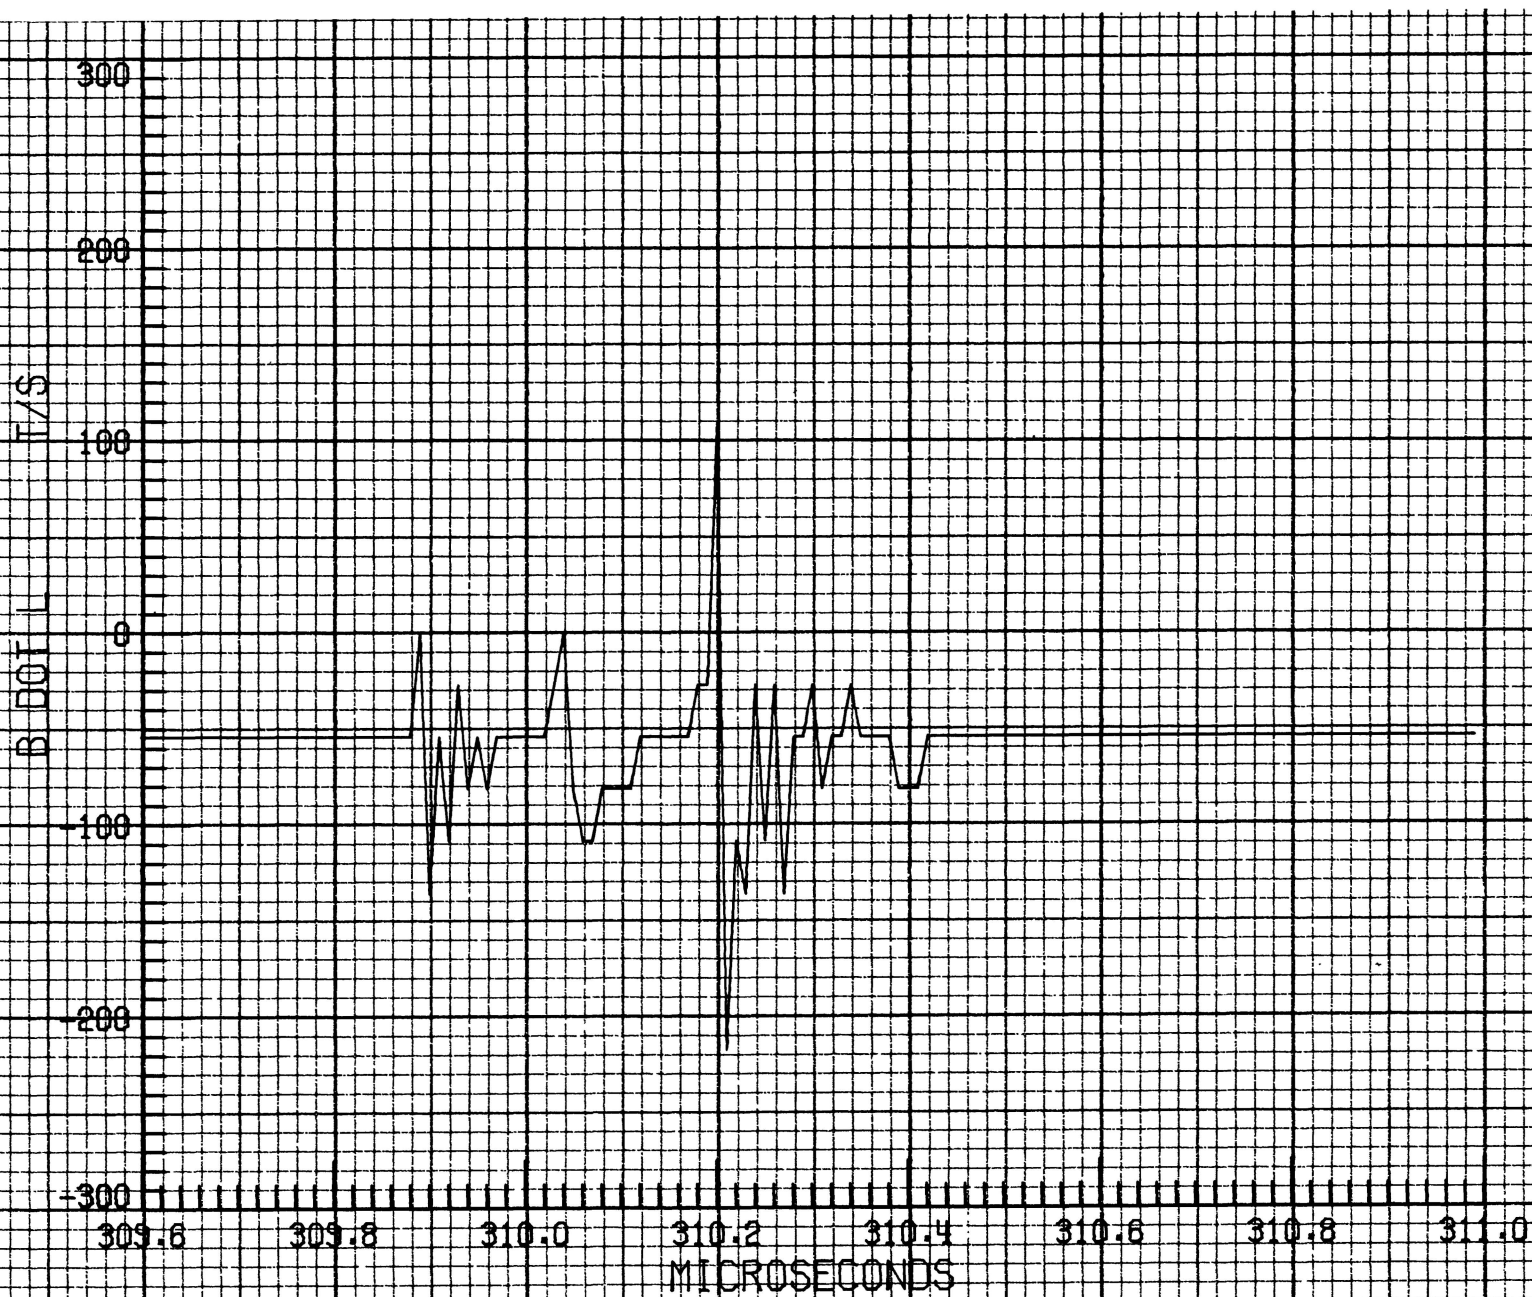
Figure 17. - B-dot sensor - flight 81-041, record 2.

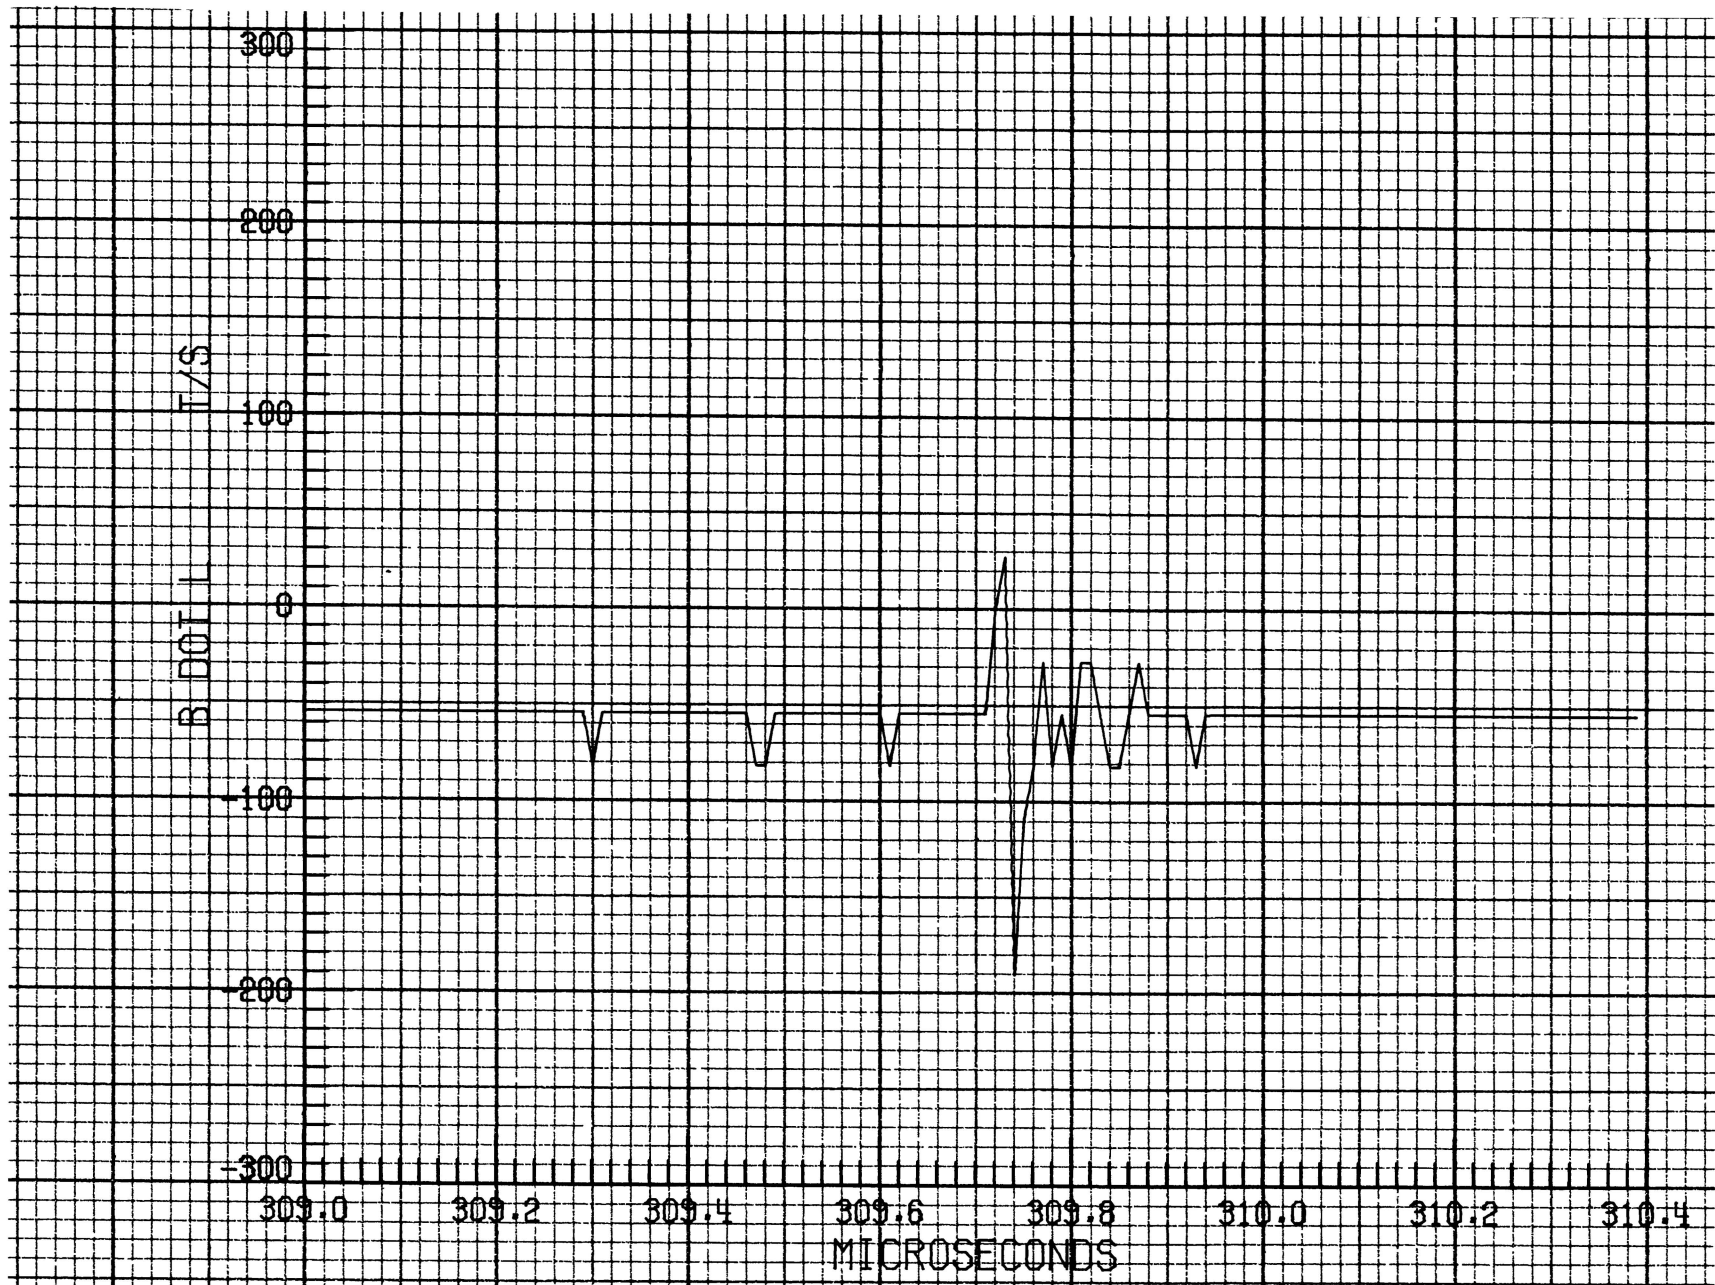
Figure 18. - B-dot sensor - flight 81-042.

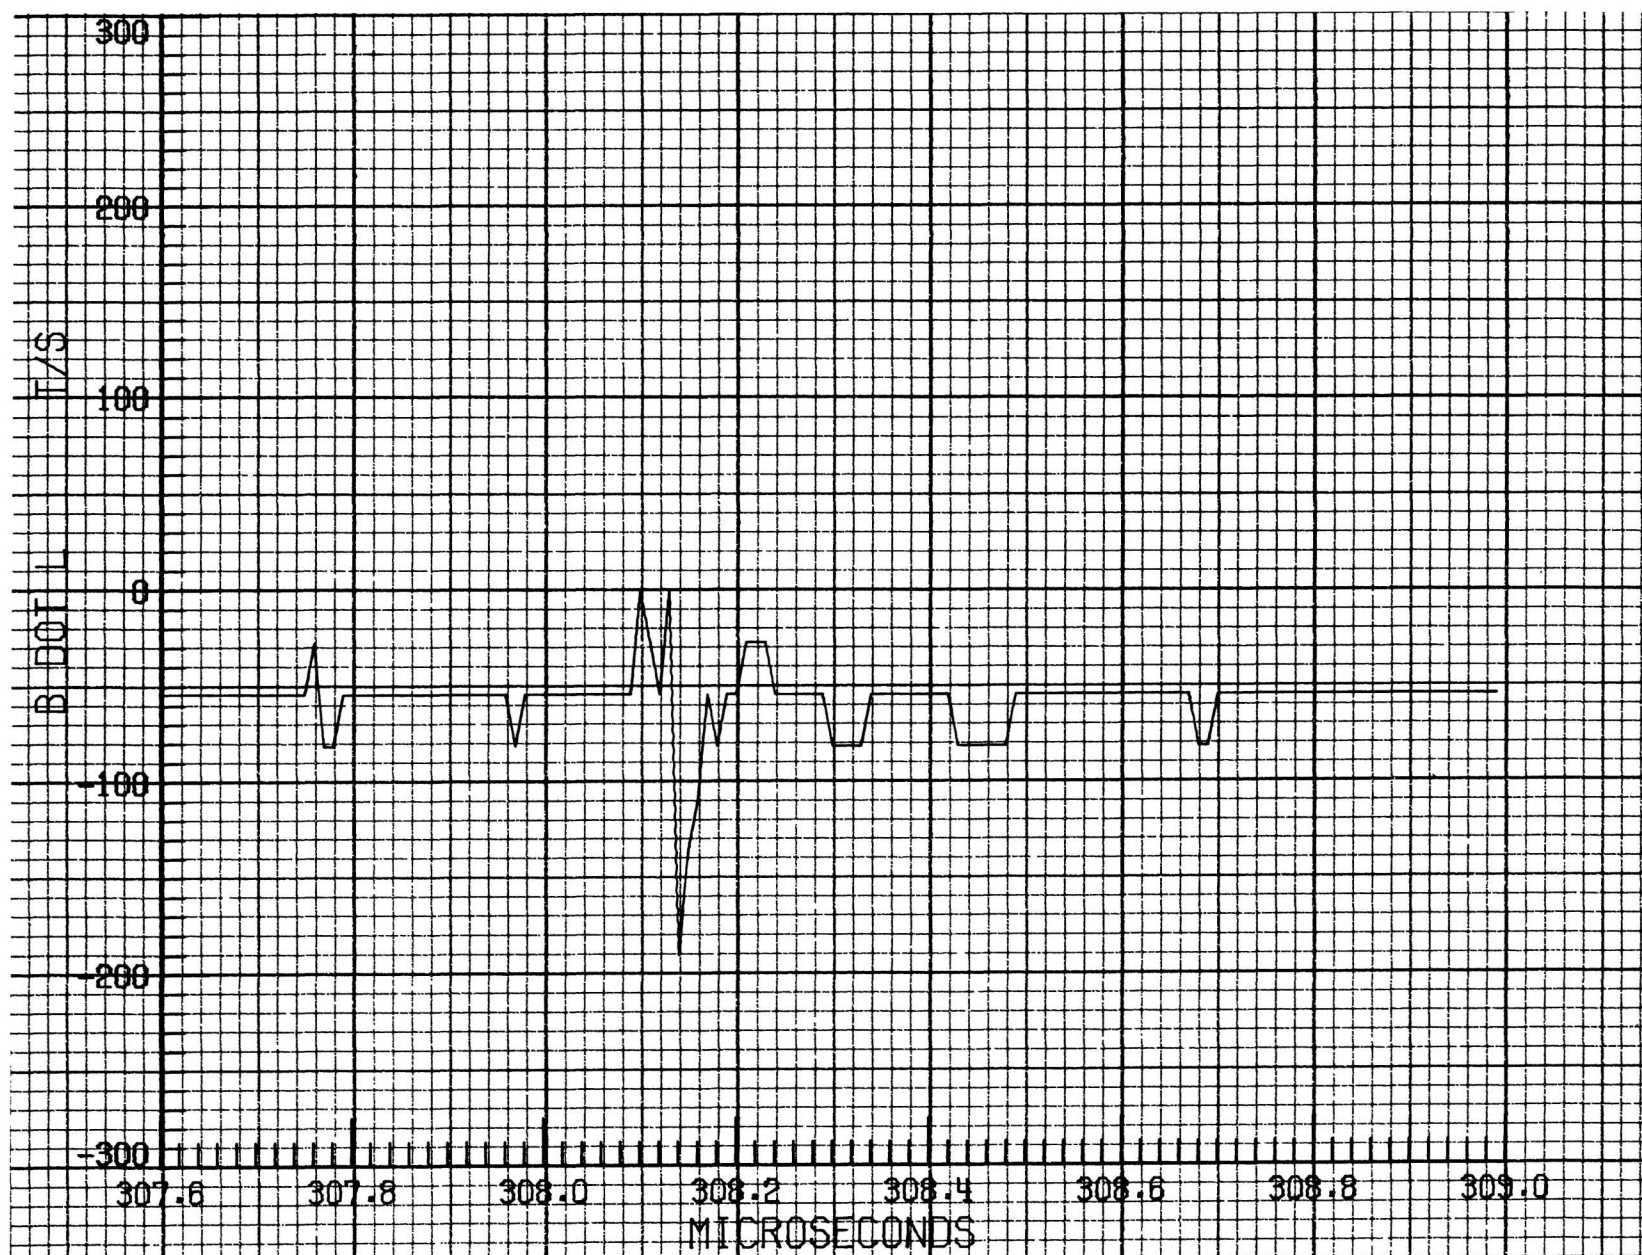
Figure 19. - B-dot sensor - flight 81-043, record 1.

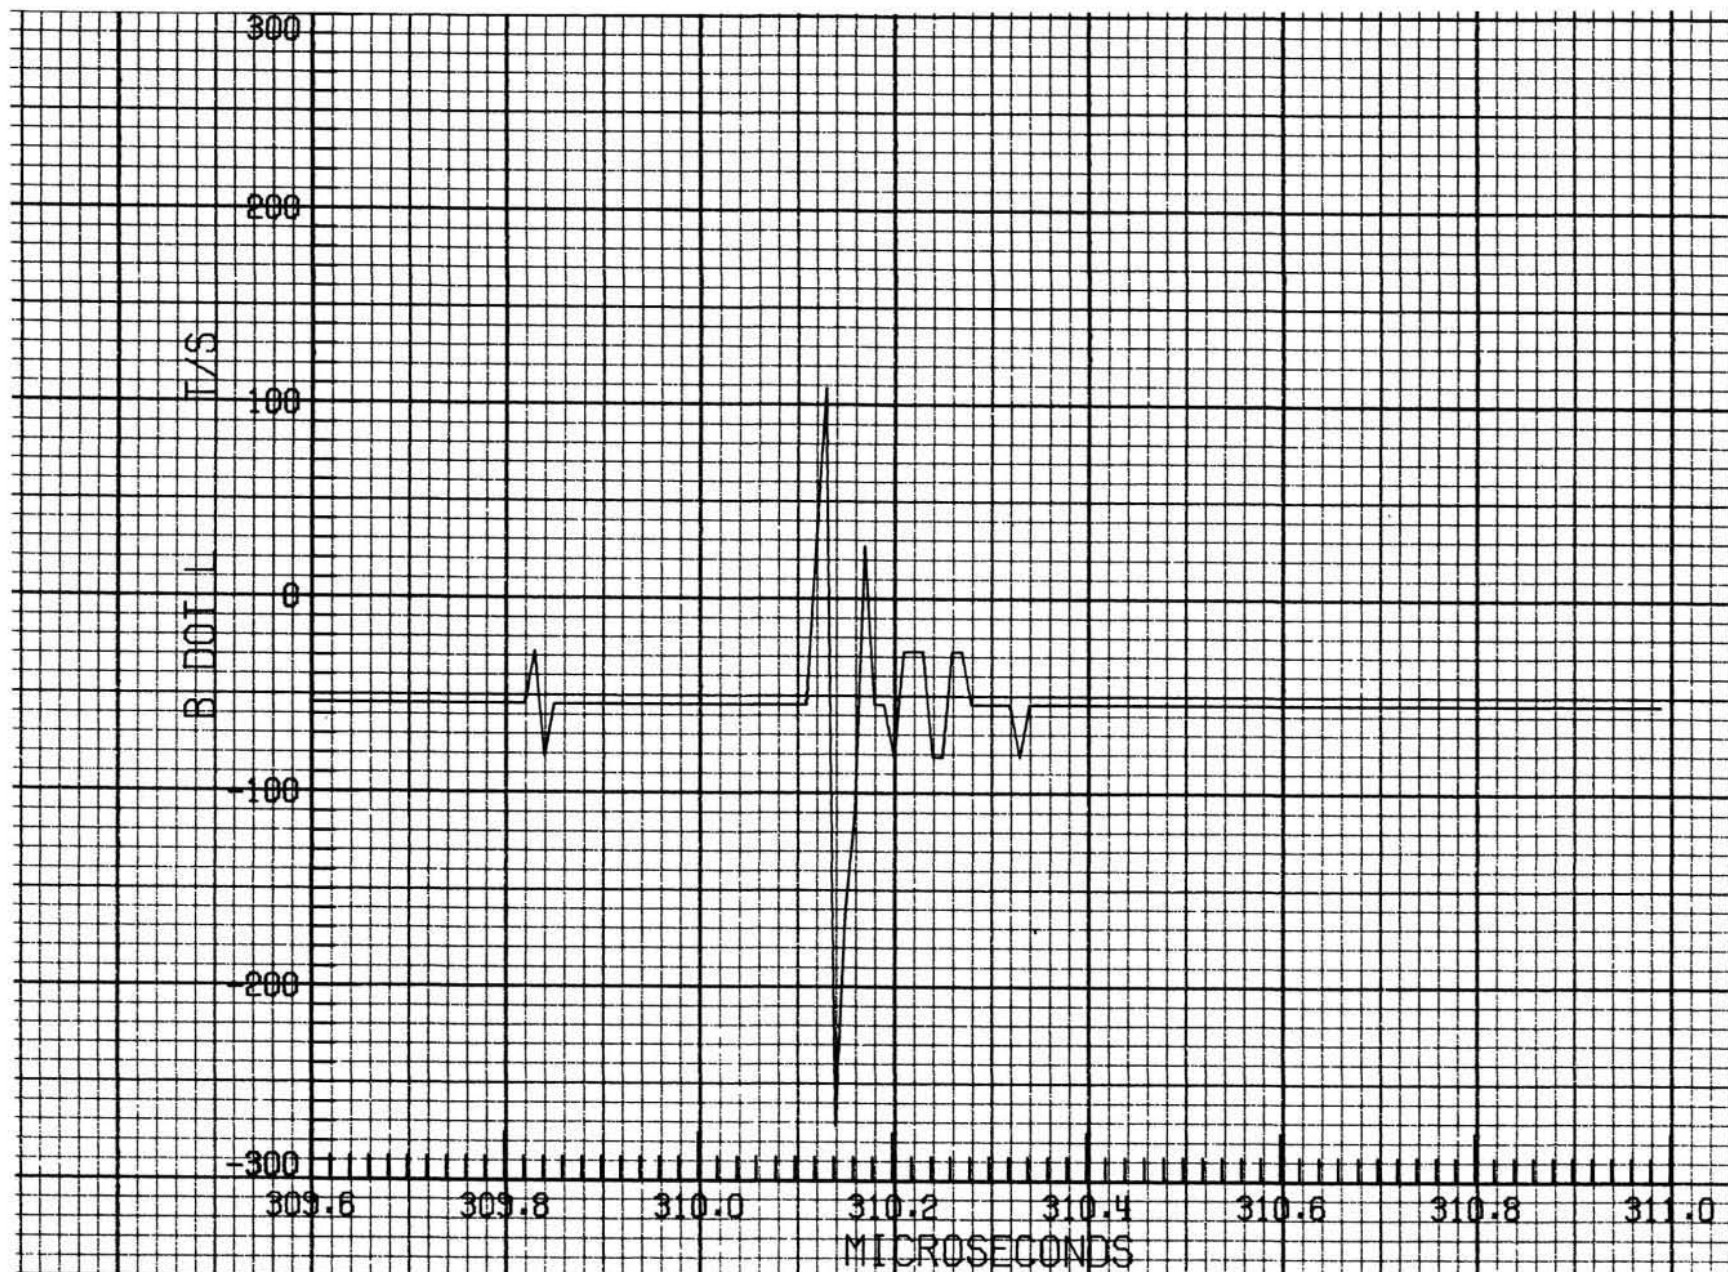
Figure 20. - B-dot sensor - flight 81-043, record 2.
